STANDARD DETAILS For Hyde County N.C. Flood Mitigation Assistance Grant 5161-004

22-089
D-0000
D-6

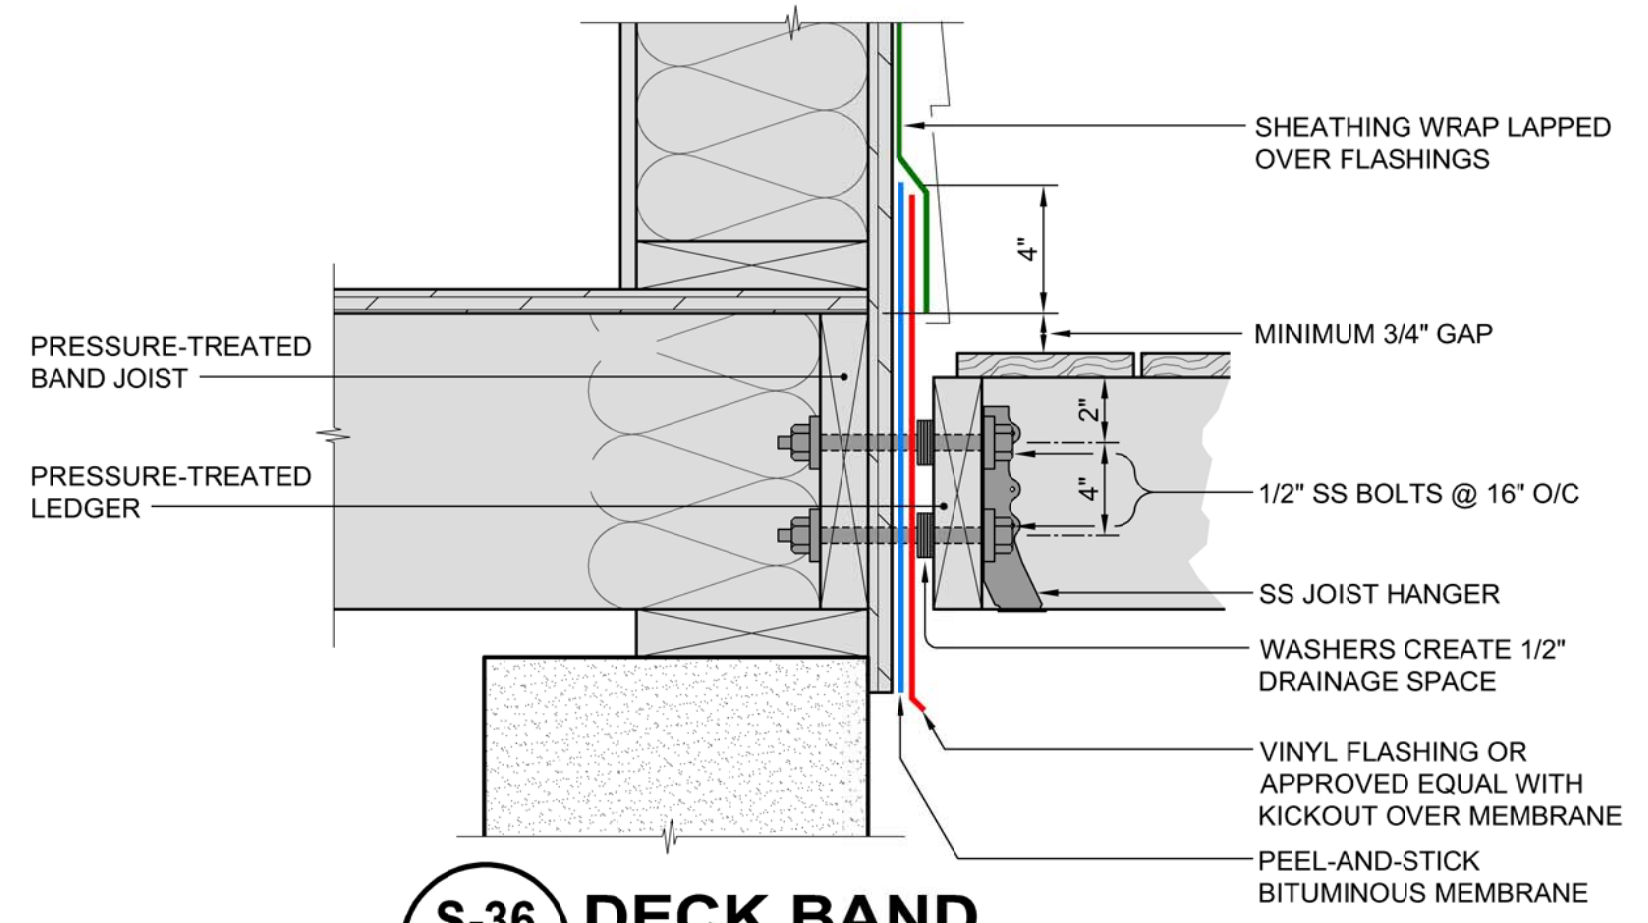
S-36 DECK BAND FLASHING DETAIL
NOT TO SCALE DATE: 7-31-18
Details Developed By APPLAN Consulting Engineers

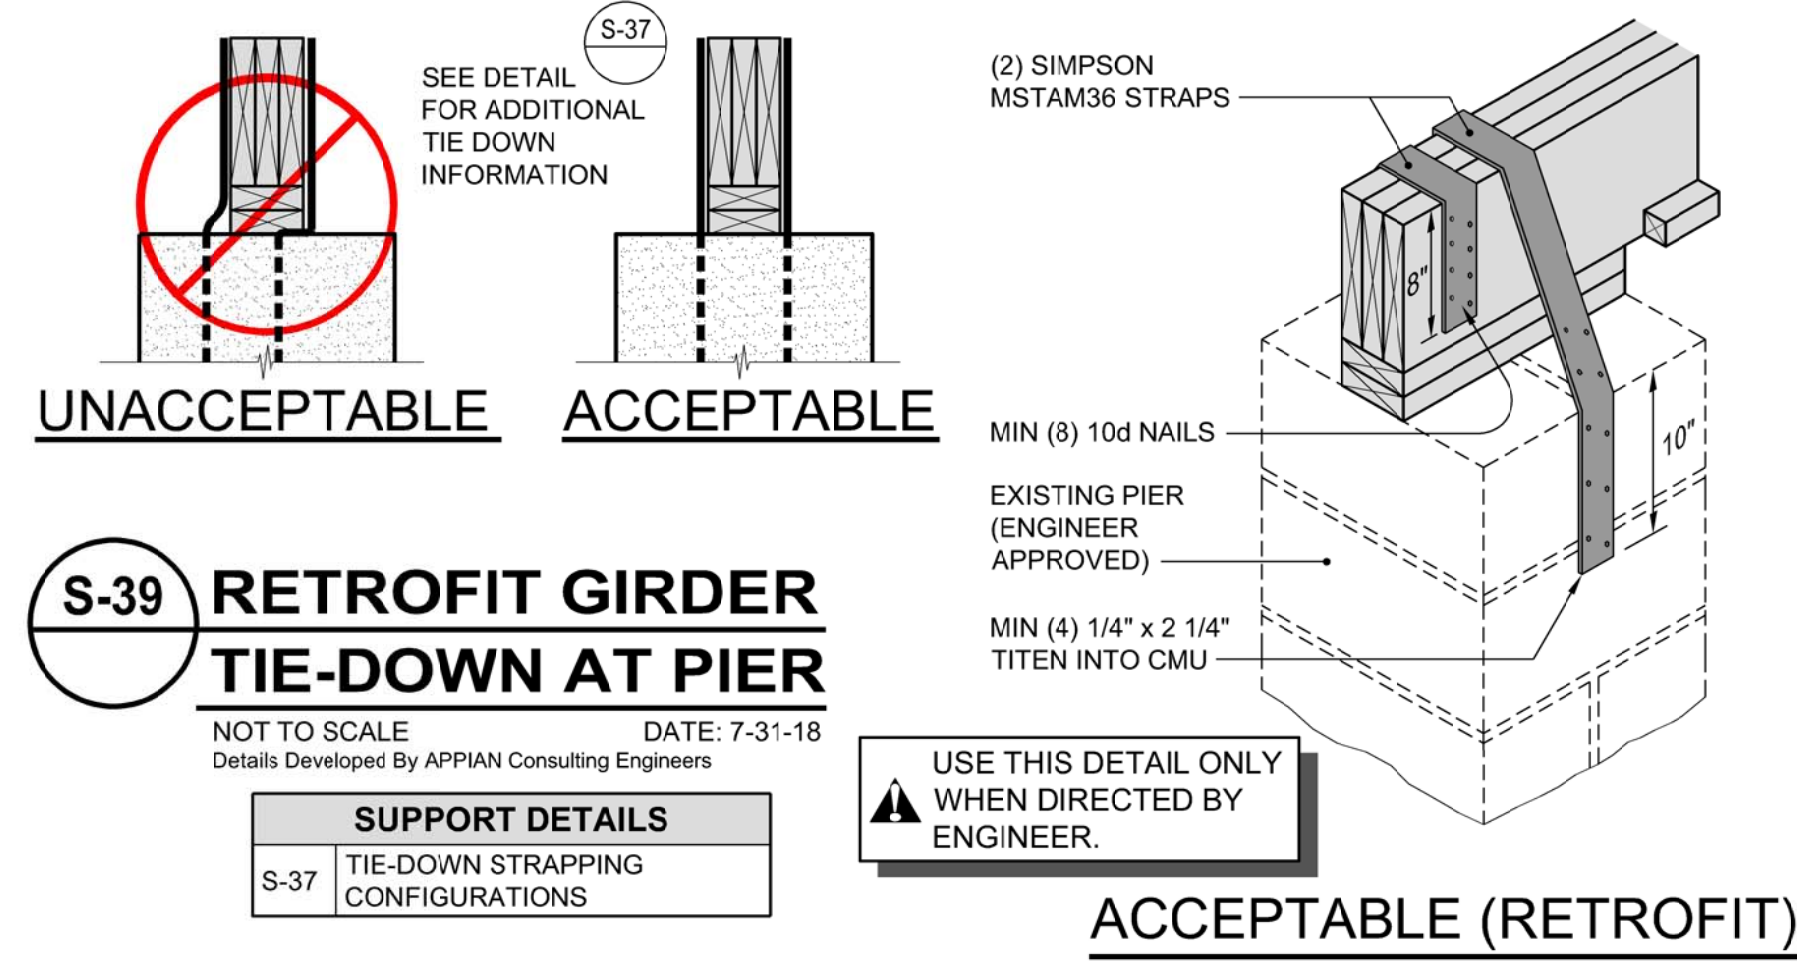
S-39 RETROFIT GIRDER TIE-DOWN AT PIER
NOT TO SCALE DATE: 7-31-18
Details Developed By APPLAN Consulting Engineers

USE THIS DETAIL ONLY WHEN DIRECTED BY ENGINEER.

ACCEPTABLE (RETROFIT)

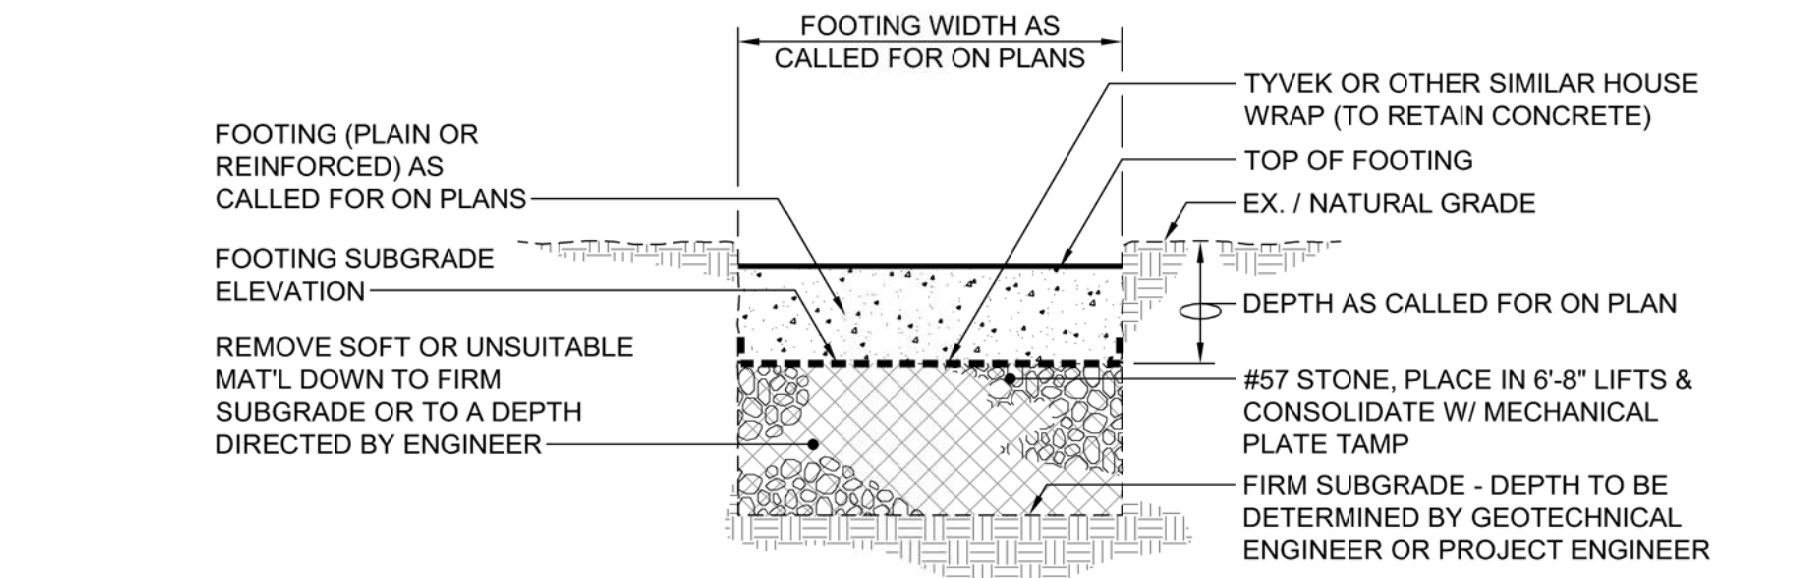
A-A FOOTING TRENCH CROSS SECTION

S-38 IMPROVING A WEAK FOOTING SUBGRADE
NOT TO SCALE DATE: 6-15-16
Details Developed By APPLAN Consulting Engineers

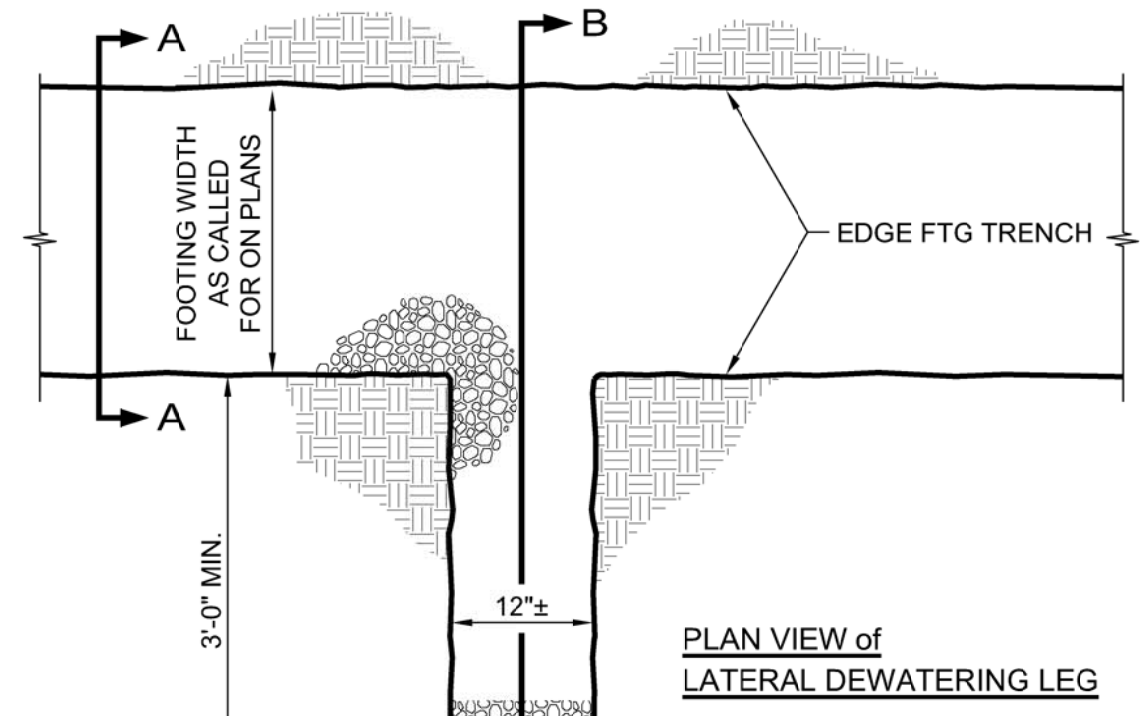
PLAN VIEW of LATERAL DEWATERING LEG

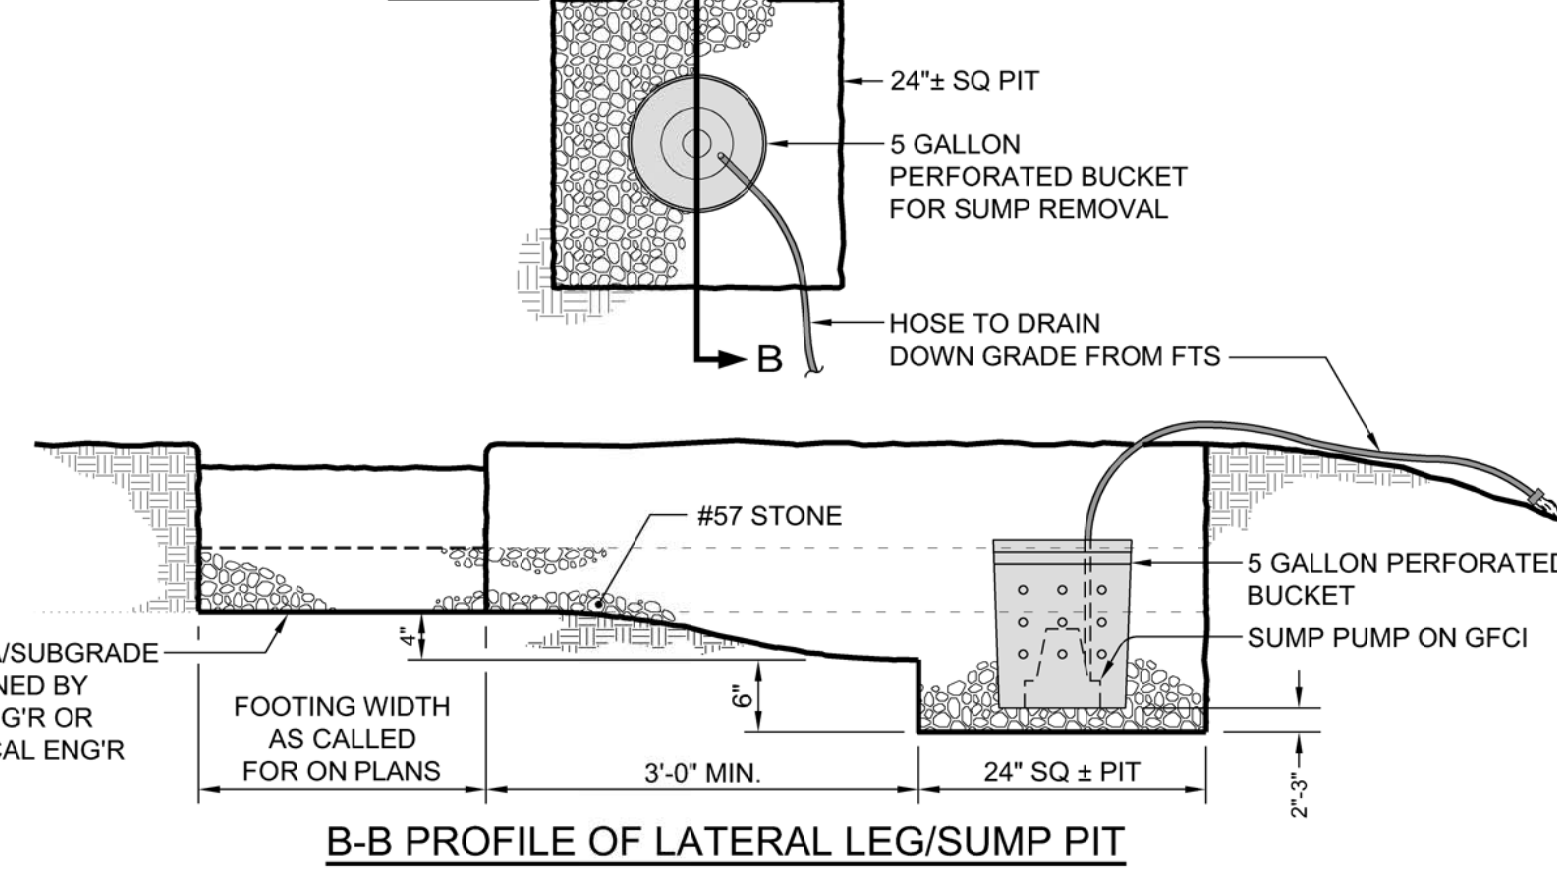
B-B PROFILE OF LATERAL LEG/SUMP PIT
